Retrofitted URM cavity walls experimentally validated and a simplified out-of-plane assessment

How should the post-retrofit capacity of URM cavity walls be assessed? An extensive testing programme was executed to determine the out-of-plane capacity of cavity walls when retrofitted with shear-transferring cavity ties. Walls were tested under semi-cyclic and dynamic shake-table loading. A tie pattern was devised that enabled a cavity wall response corresponding to the model for solid wall behaviour as contained in Part C8 of the MBIE/NZSEE Guidelines. Two different cavity wall typologies were tested (1) two single clay brick leaves separated by an air cavity and (2) two-leaf solid clay brick walls with an external single leaf brick layer separated by an air cavity. Retrofitted walls were able to sustain large mid-height displacements when subjected to out-of-plane loading and had a substantial increase in load-carrying capacity when compared to the walls without shear-transferring ties. Experimentally attained results showed good agreement with theoretical displacement and load-carrying predictions. It was concluded that for practical seismic out-of-plane assessment purposes, walls

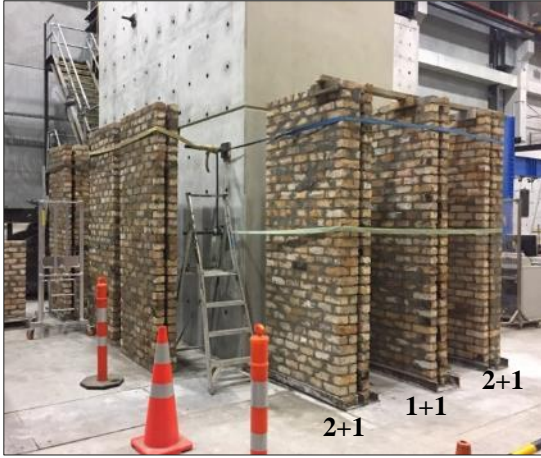
(a) Wall specimens following construction (showing different wall typologies)

Figure 1: Wall specimens and details

The experimental testing programme was conducted using six purpose-built full-scale URM walls (Fig. 1a). The walls were 3000 mm high and 1150 mm wide. Three of the walls had single leaves of brick on either side of the cavity, and were designated “1+1”. The other three walls had a double inner leaf and a single outer leaf, and were designated “2+1”. The cavity width of all walls was half the thickness of a brick, approximately 50mm. Wall heights, typologies, and cavity thickness were all chosen to approximate an upper storey wall in a typical URM building.

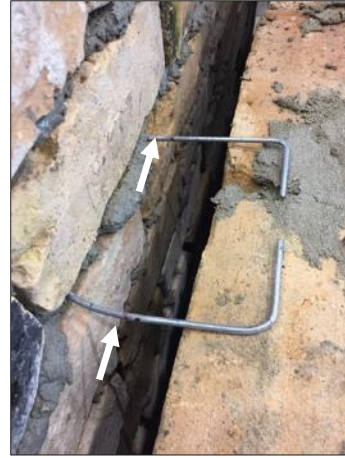
(b) Notched wire hoop simulating historical as-built ties.

In historic URM cavity wall construction, flexible wire ties were inserted into the walls to connect the leaves across the cavity. Following the methodology employed by Giaretton (2016c), these as-built wire ties were simulated in the specimen walls using 4.0 mm steel wire bent into open hoops (Fig. 1b). Deterioration of the as-built ties was simulated by notching the wire hoops that were used in the specimen. Wire hoops were inserted every six courses, alternating between a pair of hoops and a single hoop to create an offset pattern.

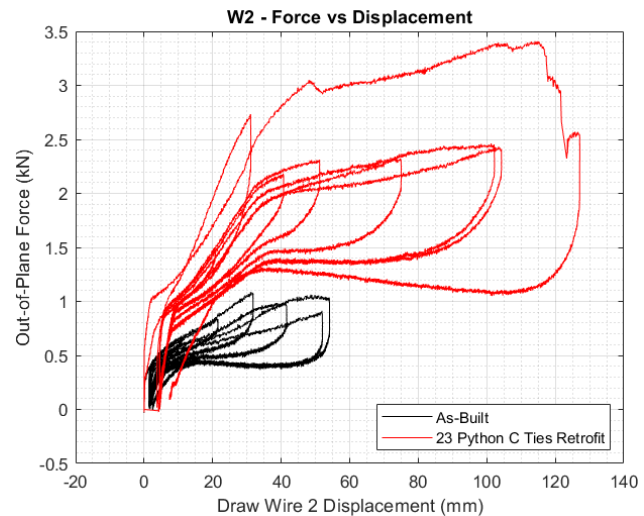
(b) W2 force vs draw-wire 2 displacement

The cavity ties were removed from the wall and testing was resumed in an as-built condition. The total peak force applied during the as-built test was approximately 1.0 kN, with high levels of relative vertical displacement between leaves. During the final test, the wall was deliberately collapsed in order to establish a baseline for instability in as-built cavity walls. Collapse was sudden and occurred at a displacement of approximately 90 mm at the mid-height crack.

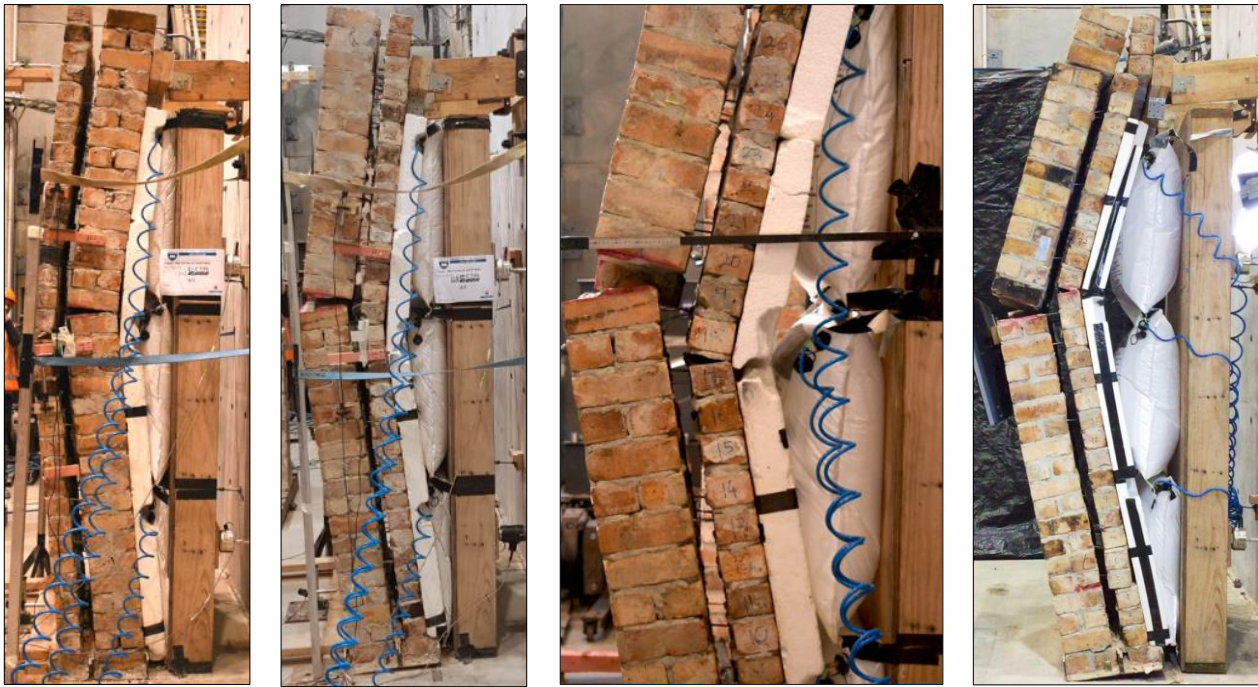
(a) W3 loaded 2+1

(b) W3 loaded 1+2

(c) W3 under high load

(d) W4 under high load

Figure 6: Double-single (2+1) walls under loading

Wall 3 (W3) was a double-single (2+1) cavity wall with gross dimensions 3000 mm by 1150 mm by 395 mm. Double-single walls are asymmetrical, and it was predicted that their response would be anisotropic. As a result, the semi-cyclic testing programme included turning each 2+1 wall specimen so that it could be tested from both out-of-plane directions. Load applied to the double leaf orientation is herein denoted as “2+1” and is shown in Figure 6a. When loading is applied to the single leaf, the orientation is denoted “1+2” (Fig. 6b).

24 shear-transferring ties were reinstalled in wall W4 and a series of displacement cycles was conducted. The maximum displacement reached was approximately 105 mm in the 2+1 retrofitted condition. Peak loading reached a plateau of approximately 8.0 kN, an increase of 23% from the as-built load capacity of 6.5 kN in the previous test. However, this loading was consistently lower than that measured in the 1+2 test, suggesting that the shorter lever arms between the masses and the pivots affect lateral capacity as predicted by the model in Section 4.2. Finally, instrumentation was removed, and the wall was loaded in its retrofit condition until collapse at a displacement of approximately 350 mm (Fig. 6d), governed by reaching the geometric instability point of the wall.

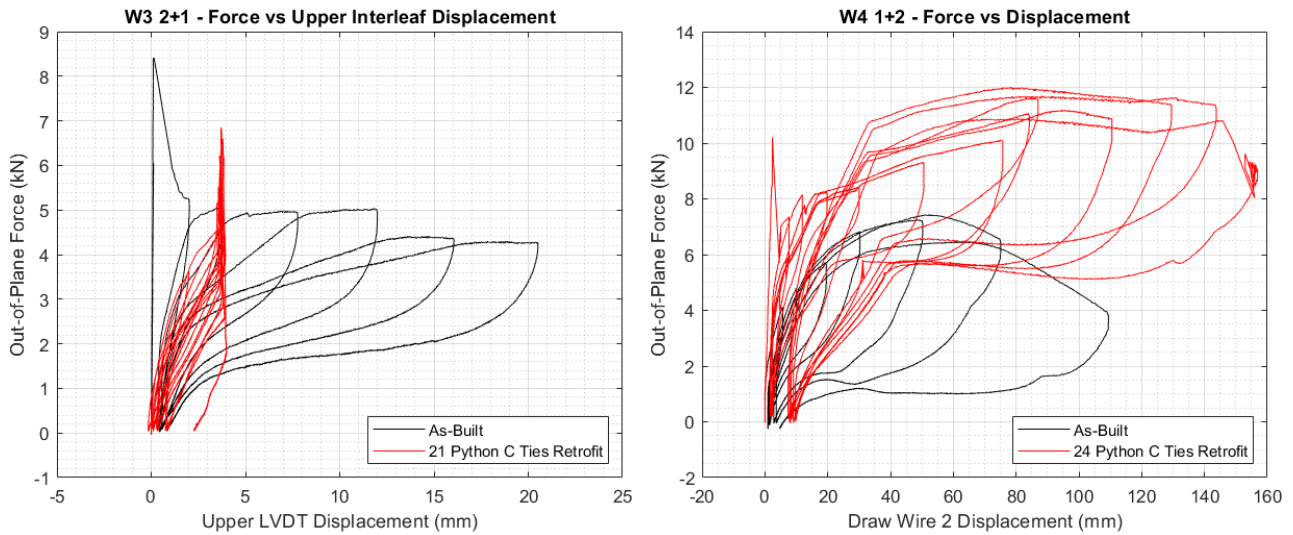
(a) W3 2+1 force vs relative vertical leaf displacement

(b) W4 1+2 force vs draw wire 2 displacement

Figure 7: Force vs displacement plots for double-single (2+1) walls

W3 was first tested as-built in the 2+1 orientation. Following initial cracking, the wall was cycled through increasing displacements up to approximately 50 mm, returning to an equilibrium position at the end of the as-built test. An LVDT measured high relative vertical displacement of the leaves of the upper block, with a peak displacement exceeding 20 mm (Fig. 7a). The wall specimen was retrofitted using 21 shear-transferring ties at 460 mm horizontal centres and 400 mm vertical centres, corresponding to a row of ties every four courses. With ties in place, the crack from as-built testing between courses 17 and 18 did not initially reopen, but a new crack formed between courses 21 and 22 during testing. The wall reached approximately 155 mm at the mid-height crack and returned to an equilibrium position with minor residual displacement. During the 155 mm displacement cycle, the crack between courses 17 and 18 which had occurred in the as-built test reopened, and the block between course 18 and 21 moved semi-independently of the upper block, at a separate angle. The wall was able to return to a stable equilibrium, and it was subsequently able to sustain displacements in the opposite loading direction. Additionally, the upper LVDT measured a peak interleaf vertical displacement of approximately 4 mm during the tie retrofit test, suggesting that the cavity wall leaves acted compositely as a semi-rigid body and relative displacement was limited.

Ties were removed from the wall and displacement cycles commenced for testing in the as-built condition. A displacement of 110 mm was achieved with a rapidly-decreasing total lateral force, suggesting that instability would shortly follow. The wall was rotated to the 2+1 orientation and re-tested, without ties being reinstalled. Results for the as-built tests were similar in both orientations with a peak load of 7.4 kN in the 1+2 orientation and 6.5 kN in the 2+1 orientation.

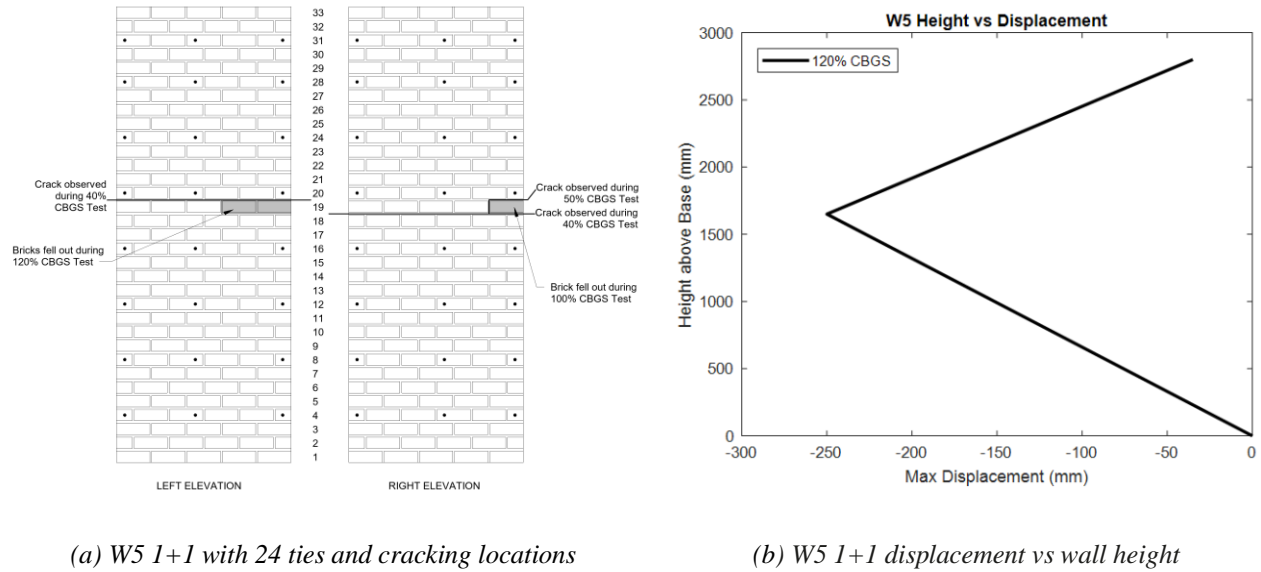
(a) W5 1+1 with 24 ties and cracking locations

(b) W5 1+1 displacement vs wall height

Figure 8: W5 dynamic testing cracking patterns and displacements

Cracking occurred between course 18 and 19 on the outer leaf and course 19 and 20 on the inner leaf, commencing at 20% of the CBGS record and becoming pronounced at 40% (Fig. 8a). Stable rocking behaviour became evident at 40% and continued throughout the testing programme. The observed rocking behaviour closely followed idealised models of rocking. The ties maintained a constant cavity distance between the two leaves of the wall. The wall rocked as two separate portions, and these portions remained essentially planar and rigid as they rocked one atop the other. Under high levels (100% of CBGS record and above) of loading, a secondary crack formed between course 2 and 3, but the lower portion still rocked as a rigid body. Rocking behaviour can be seen in stills taken from testing videos (Fig. 9).

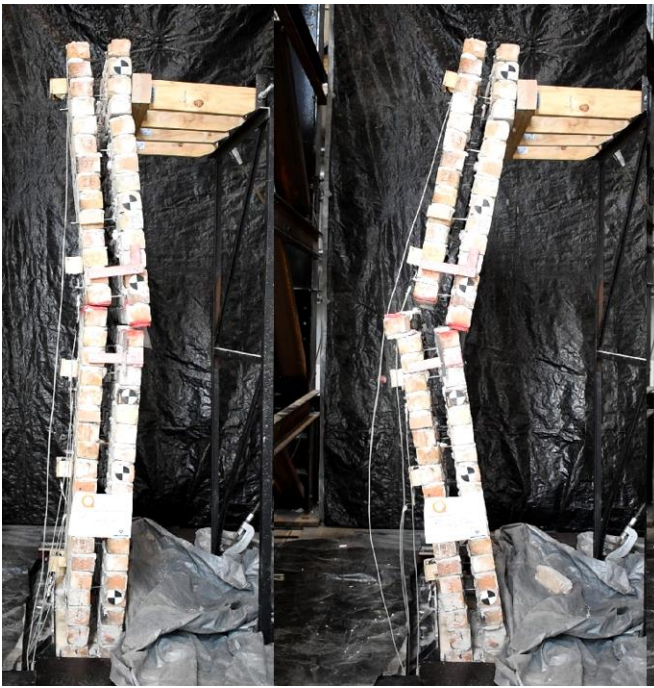
Figure 9: Wall W5, stills from video record of testing showing rocking behaviour and collapse

Alongside the classical rocking behaviour, a gradual offset between the upper and lower portions of the wall occurred. After six shaking records of testing, reaching 60% of CBGS, the upper portion of the wall came to rest at a small misalignment from the lower portion (~5mm). The offset remained small during testing to 80% of CBGS. After 100% of CBGS the offset between upper and lower portions increased to around 20 mm, but the wall retained gravity support even with a reduced contact area and was able to self-centre.

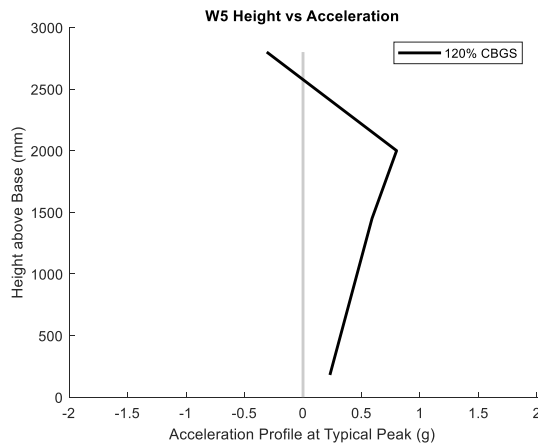
(a) W5 1+1 typical acceleration profile vs height at a specific point in time

Figure 10: W5 and W6: typical accelerations profile vs height. Note that the plots do not reflect overall maximum recorded accelerations, but provides a typical example of an acceleration profile along the wall height at a specific point in time.

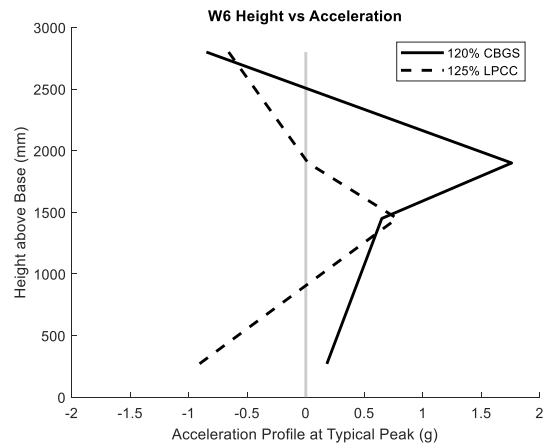
(b) W6 2+1 typical acceleration profile vs height at a specific point in time

record than the CBGS record, peak displacement was lower, at around 80 mm. Peak shake table acceleration was 0.96g. A typical acceleration profile for the wall during testing is shown in Figure 10b (note that the plot does not reflect overall maximum recorded accelerations, but provides a typical example of an acceleration profile along the wall height). The wall lost one additional brick from the rocking zone but remained self-centred at rest. Wall W6 did not collapse under dynamic loading despite being subjected to approximately 250 rocking cycles over 21 earthquake records varying from 5% to 125% CBGS and 40% to 125% LPCC.

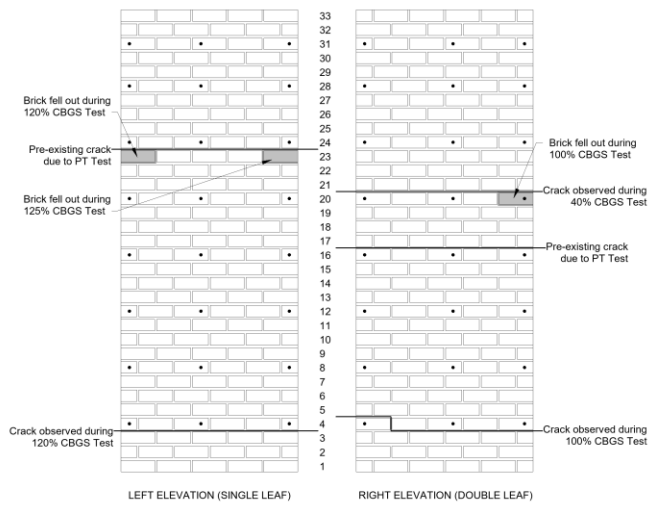
(a) W6 2+1 ties and cracking locations

Figure 11: W6 dynamic testing cracking patterns and displacements

At 40% of the CBGS record, cracking was observed between course 20 and 21 of the double leaf, and between course 23 and 24 of the single leaf. Although the cracking did not occur at the same course in both leaves of the wall, the observed rocking behaviour still agreed with classical models of rocking. Cavity ties maintained a constant separation between inner and outer leaves. Both upper and lower portions rocked as rigid planar bodies.

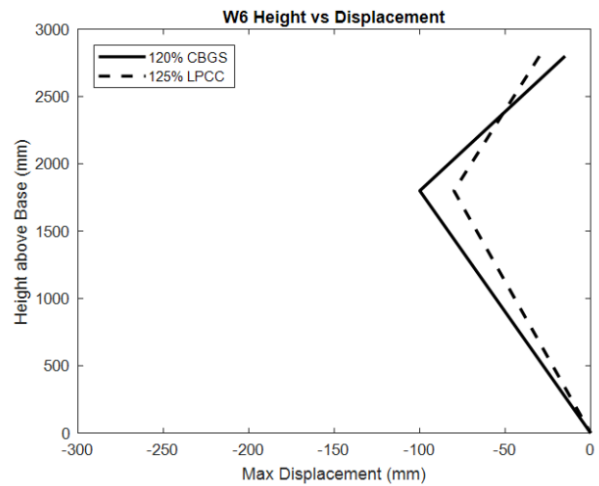
(b) W6 2+1 displacement vs wall height

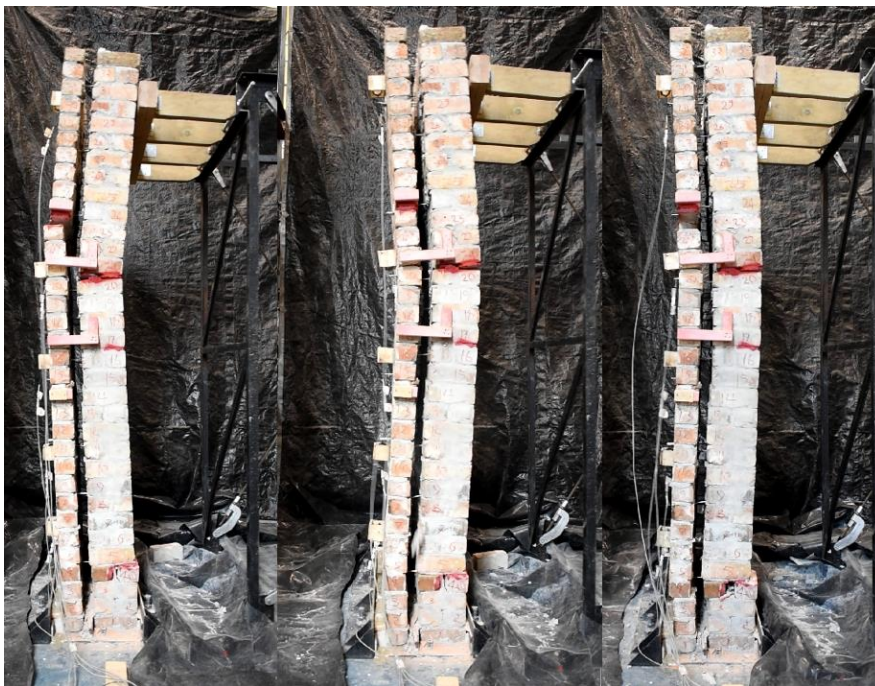
Figure 12: Wall W6: stills from video record of testing showing rocking behaviour

The wall was then subjected to 4 repeated earthquakes of 120% of the CBGS record, then an earthquake of 125% CBGS. Two further bricks were lost from the mid-height region during this testing, as illustrated in Figure 11a. Peak acceleration in these tests was 1.8g at the top of the wall, with a peak mid-height displacement slightly in excess of 100 mm. Peak shaking-table acceleration was 0.67g. Despite the loss of bricks at the contact zone between the upper and lower portions, the wall continued to display rocking behaviour and to self-centre (Fig. 12).

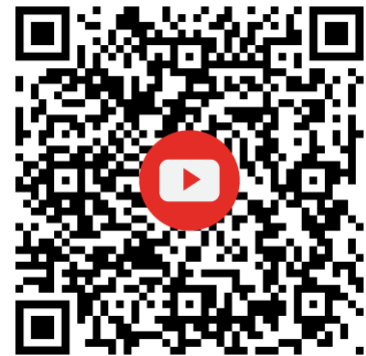
Scan QR code to view this test video

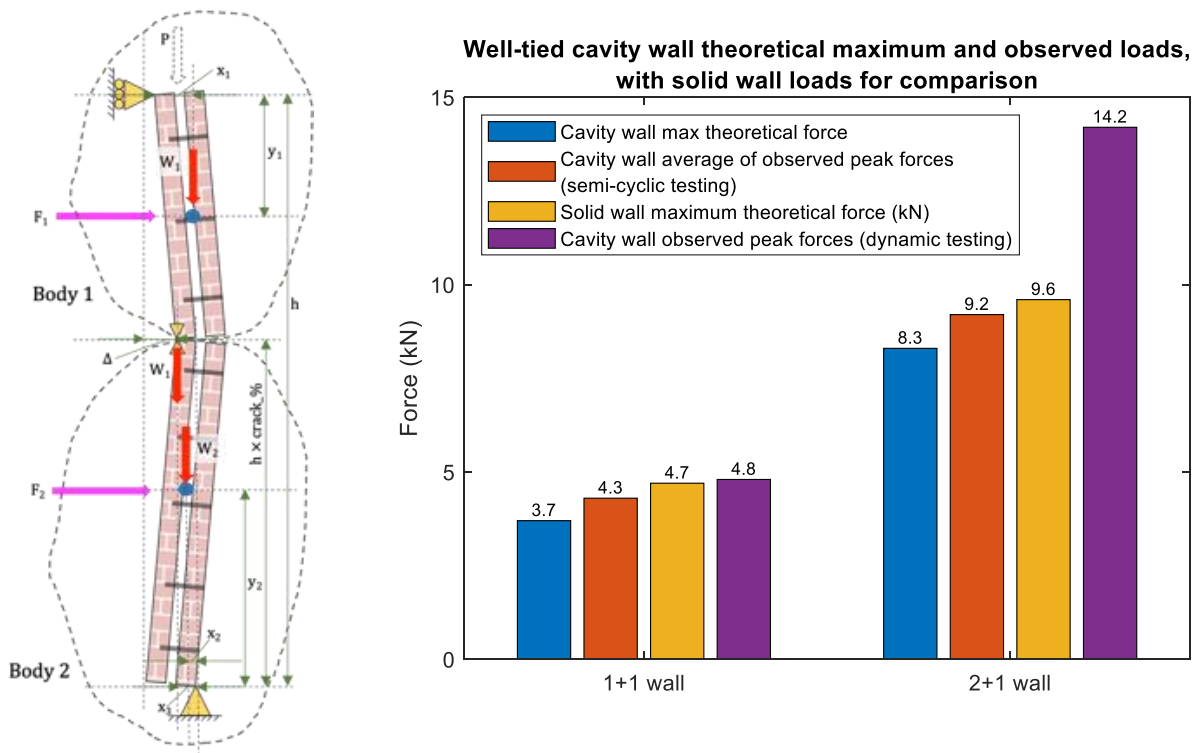
(a) Force-based model of wall system

(b) Comparison between theoretical loads and observed loads

Figure 14: Well-tied, pseudo-rigid cavity wall rocking model

A simplified model of the well-tied wall system was devised to determine the theoretical force capacity of walls, and is presented in Figure 14. The model is closely related to that given in Part C8, and uses restoring moments derived from the wall sections' weights to resist lateral loading, with the peak load capacity occurring at the instant of uplift of the outer wall section. The predicted loads in this model have good agreement with loads derived using NZS 1170.5 Section 8 (Parts and Components).

Cavity walls are modelled as attracting a lower load than solid walls of the same total thickness, as a result of their lower mass. As a concomitant, the walls also have less restoring moment to resist loading. The net result is a minor difference between solid and cavity walls, with solid walls having a slightly higher predicted maximum force capacity.

Under semi-cyclic testing, the specimens were able to withstand peak loading greater than the predicted maximum for cavity walls, but lower than the maximum predicted for solid walls. Substantial variation in the force-based capacity of as-built walls resulted from material variability, significant cracking damage, and restraint conditions. However, each wall in a tie-retrofitted condition had increased force capacity over the same wall specimen in its as-built state.
